Thermal Stresses in the COGD Skirt Under Flooded Conditions

Case study

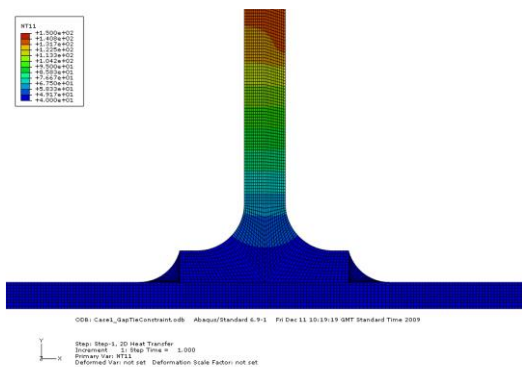
Figure 1 Model with tie node constraint

The assessment showed that boiling of the PVCW would not occur but that the temperature of the PVCW supply to the COGD skirt could increase by up to 150°C whilst the liner floor temperature would remain substantially unaffected. Axisymmetric finite element models of the COGD skirt have been created and analysed. No significant differences in the hoop and axial stresses are evident between the two configurations.

High axial bending stresses occur at the COGD to anchor ring weld and the maximum value is approximately 440 MPa calculated on a linear, elastic basis. Since this weld is not IoF, and there are no known defects, there is no requirement for a fracture assessment for an infrequent fault such as that, and, since thermal stresses are secondary, the code assessment is trivial and acceptable.
