Analysis and Assessment of Abnormal Trip Transient for AGR Boiler Components

Case study

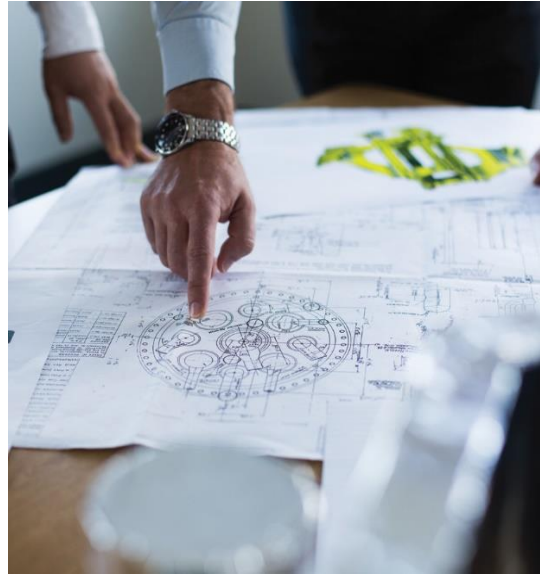
Figure 1 FE modelling of the tubeplate

The superheater penetration tubeplate was one area of particular concern. The tubeplate forms part of the reactor gas pressure boundary and operates in the creep regime.

Transient thermal loading during normal trip transients and during initial boiler feeding give rise to the potential threat of creep-fatigue crack initiation at the tube bores – the main integrity concern.

The transient thermal loading during the abnormal transient was expected to be far more severe than a normal trip. Sequentially coupled transient heat transfer and stress analyses of the tubeplate were carried out.

As expected, stresses well beyond the

shakedown limits of the structure were predicted using an elastic analysis and the transient was re-run using a non-linear analysis to assess shakedown and fatigue damage accumulation by considering strain accumulation during cyclic loading.

It was shown that the strain accumulation for the limited number of severe loading cycles experienced was low and that the state of residual stress in the body following the transient was actually beneficial for future operation, as the residual stress field induced was compressive at the tube bores.
