# Stress Corrosion Cracking in Low Pressure Turbine Rotors

## Case study

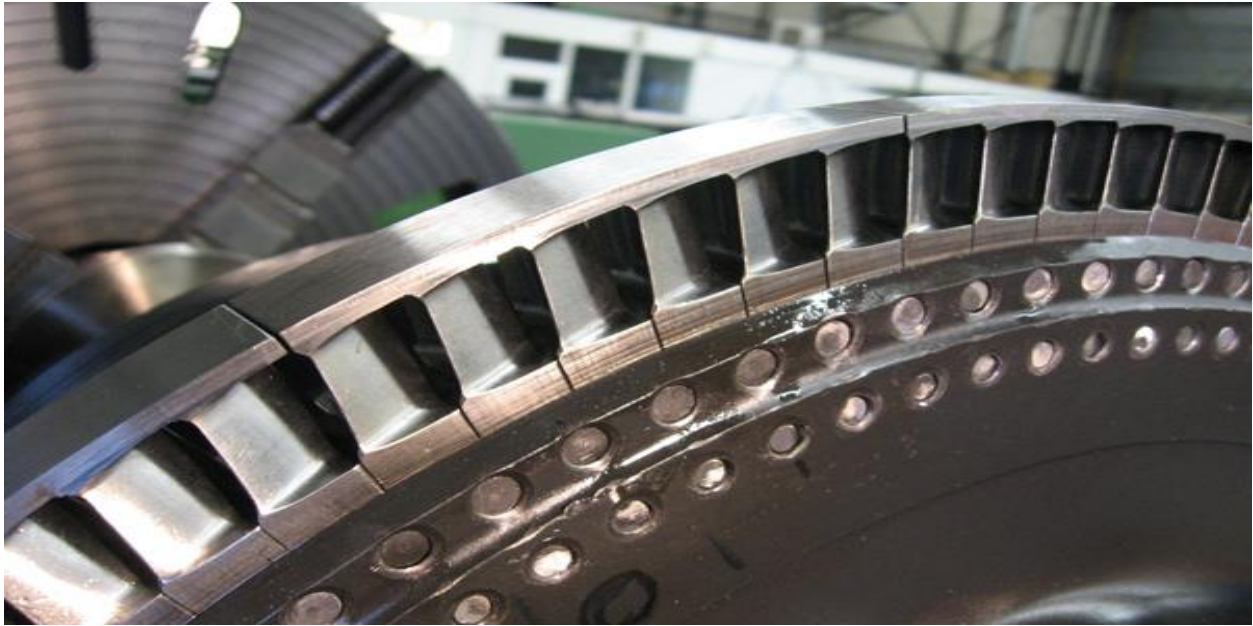
A finite element model of a sector of the rotor disc with the blades attached was constructed. The rotor disc was modelled in some detail while the turbine blades were only modelled in sufficient detail to ensure the correct loading was applied to the rotor.

The rotor was modelled using material properties that modelled both the elastic and plastic behaviour of the rotor material.
